Measurement Notes

Note 61

**Windscreen Shield Monitoring Using a Spiral Transmission Line**

**Abstract**

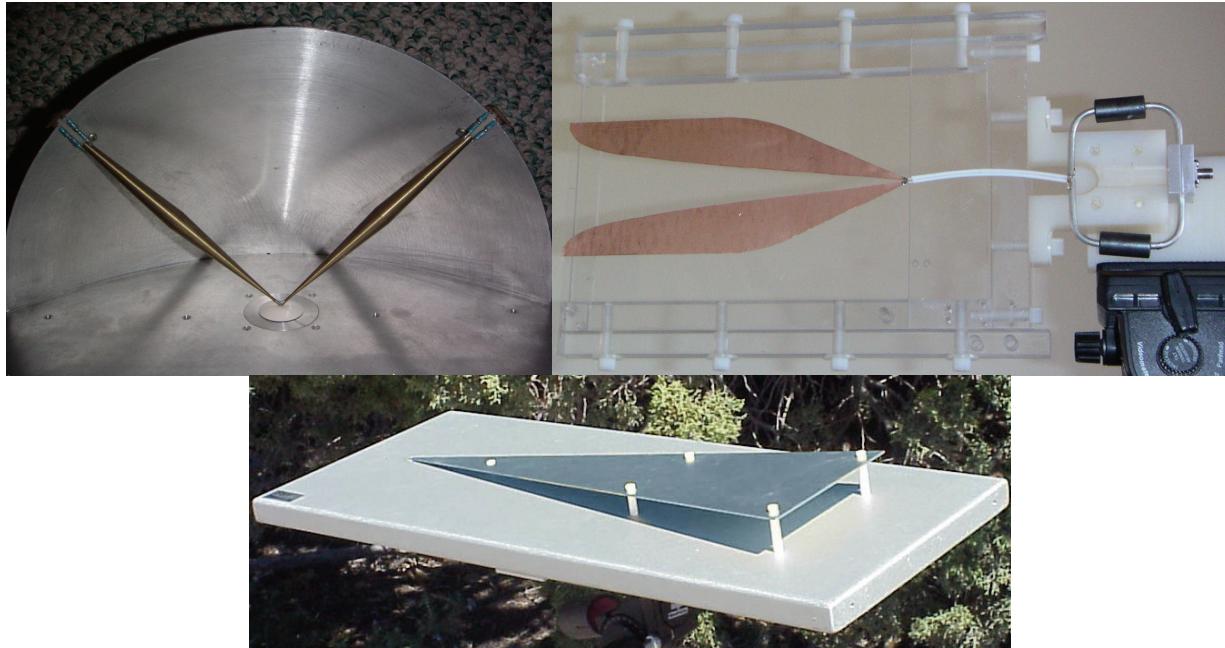
Figure 16. A collection of alternative exterior antennas used with an interior STL to detect a shielding fault: 9-inch diameter half IRA (left), Impulse Slot Antenna (right), and Farr Research model TEM-1-50 (bottom).

As a variation on the dual STL configuration, we replaced the exterior STL with a variety of alternative antennas. These included a 9-in diameter half Impulse Radiating Antenna, a Farr Research model TEM-1-50 sensor [3], and an Impulse Slot Antenna [4]; all of which are shown in Figure 16. Each of these antennas was used in receive mode, while the interior STL transmitted. These tests were carried out in the time domain, using the PSPL model 2000D pulser and the Tektronix model TDS8000 digital sampling oscilloscope. All three antennas were successful in detecting leaks.

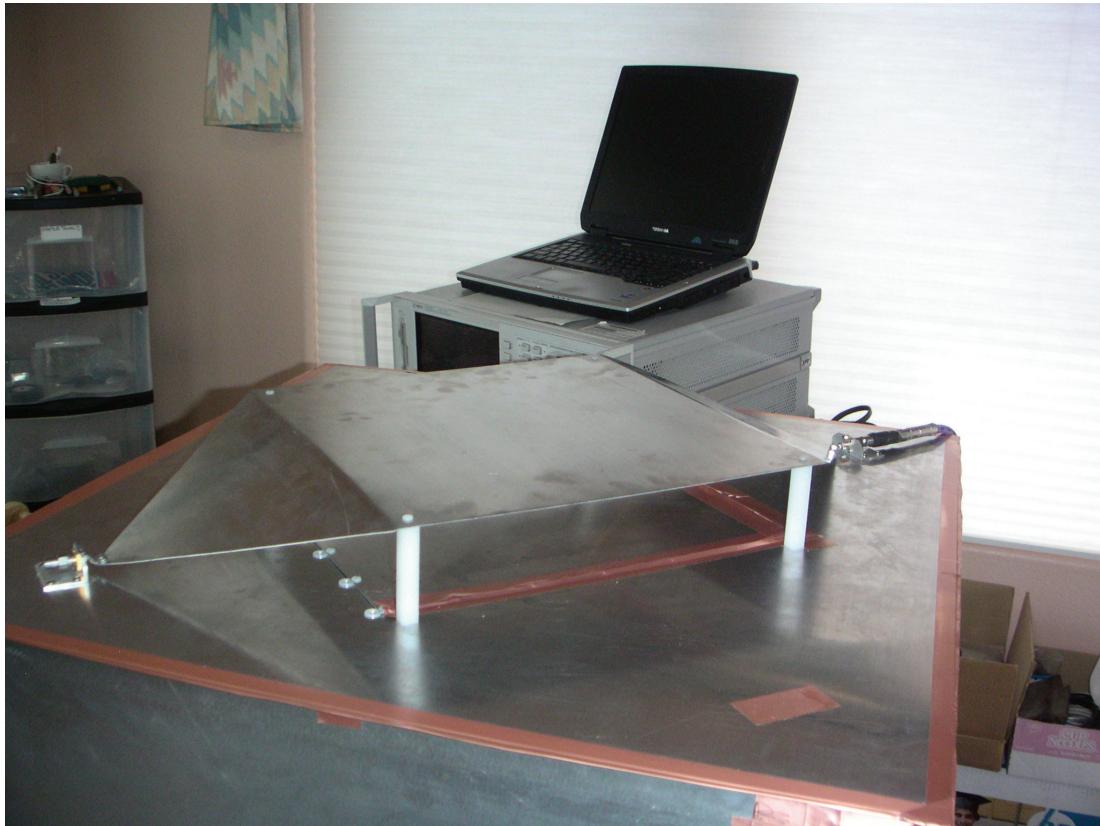
Figure 17. Exterior of the box, showing the stripline (or “blanket”), terminated in  $50\text{ }\Omega$ .

The steel box was a 2-foot cube, covered by an aluminum sheet with a  $22.9 \times 27.9 \text{ cm}$  ( $9'' \times 11''$ ) window that was either leaky or sealed (open or closed). We drove the exterior of box with a stripline terminated in  $50\text{ }\Omega$ , as shown in Figure 17. We detected fields on the interior with an STL operating in differential mode with a balun (Prodyn model BIB-100F, 200 kHz–3.5 GHz), as shown in Figures 18 and 19. Our VNA measured the leakage signal ( $S_{21}$ ), where Port 1 drove the stripline, while Port 2 detected the signal leaked to the interior. We compared the leakage signal for open and closed seams over 0.2–200 MHz.

On the exterior of the box was a stripline with dimensions 30 x 30 cm, positioned 6 cm above the ground plane. This was supported on four nylon posts located near the corners of the window opening. Triangular sections provided smooth tapers to points on the ground plane located 65 cm apart, where SMA connectors were mounted. Thus, along with the ground plane, the stripline formed an approximate  $50\text{-}\Omega$  transmission line.
